NAVAJO - BROWN VANDEVER URANIUM MINE

PRELIMINARY ASSESSMENT REFERENCES

PRELIMINARY ASSESSMENT FOR THE NAVAJO - BROWN VANDEVER URANIUM MINE

PATRICK MOLLOY
HEALTH PHYSICIST, NAVAJO SUPERFUND OFFICE

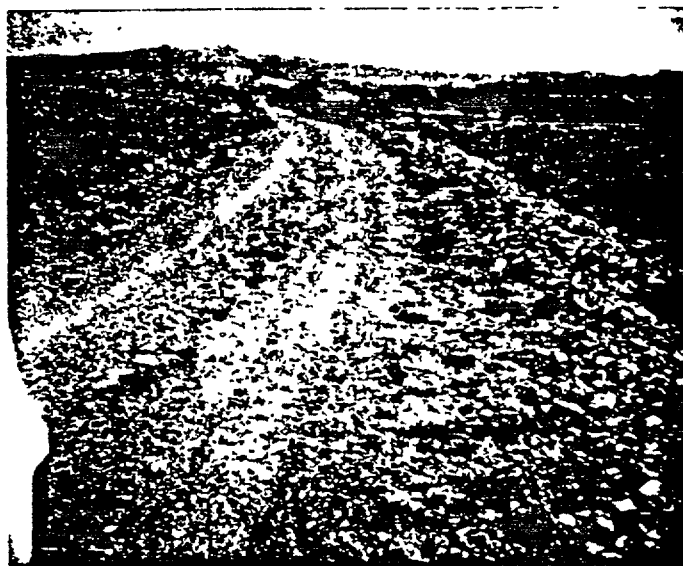
22-11

Reading: 105cpm (TSP-11) @ EDGE OF ROAD

7. DESCRIPTION "HOT ROAD" WEST OF B. V. RESIDENCES, SUP-
FACE WORKS WASTE PILES @ RIGHT MIDDLEGROUND, MT. TAY-
LOR @ UPPER LEFT BACKGROUND AS REFERENT

- * There are 7 residences on site: not all these residences are connected to the IHS water system.
- * The old haulage road (for ore transport) is plainly visible and shows definite erosion: The road that obtains access to the site was at one time the haulage road. There is radiometric evidence that contaminants are migrating off site (18, pg #2).

- * The Navajo Superfund Office FIT digilert alerted (enabled) inside the vehicle being used for reconnaissance at one point along the "Hot Road" (3; Frame #22): enable/alert on the device is set at .098 mR.hr-1.

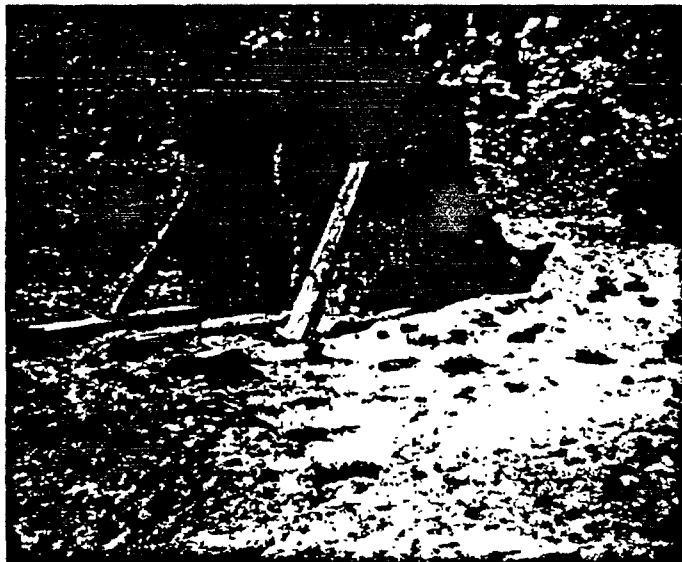
33rd ER.

Reading: 10uR.hr⁻¹ (LUDLUM=19), 104cpm(ESP-II) @ WEST
 FACE OF SHACK

7. DESCRIPTION B. WANDEVER TIMBERED SHAFT. SHAFT AT AN IN-
CLINATION OF 10° FROM VERTICAL. CIRCULAR APERTURE
ON S FACING WALL IS WIRED OVER BUT WIRE IS EASILY
REMOVED, SHAFT ASPIRATES, "300 FT. DEEP" B. V. TO

A timbered shaft inclined at approximately 10° from the vertical, was driven into the dip of the Todilto formation approximately 1000 ft. west of the inclined adits (3; frame #33). This shaft was reported to be approximately 300 ft. deep (14; page #6): drifts were also excavated northwest and northeast from the shaft.

- * The timbered shaft retains a shack at its mouth, however, access to the shaft can easily be gained by removing a wire grate covering the portal (3: Frame #33). Additionally, the shaft "aspirates" under certain meteorological conditions, contributing to the area Radon burden.

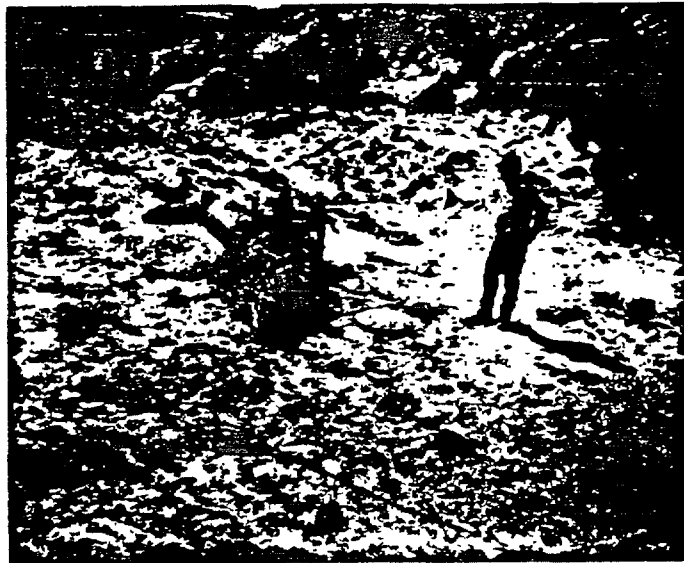
33rd FR.
 (VENT. SHA. VERTICAL!)

7. DESCRIPTION VERTICAL VENTILATION SHAFTS(2), HOSTEEN
BROWN VANDEVER AT RIGHT MIDDLEGROUND, SHAFTS "300
FT. DEEP" - B. V. TO P. MOLLOY, APRIL 11, 1990, LOOK-
WNW

Two, two-foot diameter vertical shafts were excavated between the inclined adits and the timbered shaft in order to provide ventilation for the mining operation (3; frame #33); the ventilation shafts were reported to be approximately 300 ft. deep (Mr. Brown Vandever, personal communication, April 11, 1990).

- * The vertical ventilation shafts are poorly capped and young children in the area could easily gain access to the excavations (3; Frame #33).
- * One inclined adit is used for waste disposal (3; Frame #12).
